CLIVE THOROGOOD
BUILDING SURVEYING LIMITED

Technical Note 1: MASONRY BEES

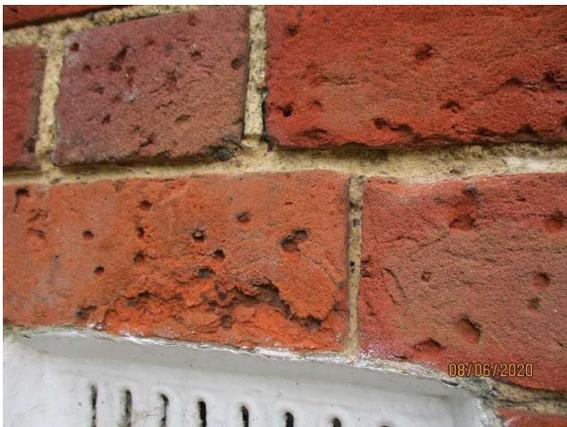
These holes, found on a residential house in Henley-on-Thames, were measured to be up to 10mm in width and also showed some shallow burrowing. The relatively soft texture of this particular brick is an easy target for the bees. Interestingly, this was on a sheltered north-facing elevation and another outbreak on this property was found on a west-facing wall - so going against the usual theory of these bees preferring sunny, south-facing elevations, which aid the germination of their eggs.

If required, severely-damaged brick faces can be re-faced using a sensitive mortar-mix; alternatively, affected bricks can be removed and re-inserted in reverse. Affected mortar joints can be re-pointed in accordance with good practice. This is best done in late summer or autumn. Because female masonry bees commonly re-use their birth nest sites; this will help break the cycle.

New mortar should not be too strong for the bricks or stone, but hard enough to discourage the bees. Any burrows can be filled with a wetter-than-usual mix to aid the flow.
